Manhole Inspection Summary

Manhole # S39UU_006MH

Insp Date: **12/19/06 10:46 AM**

Location Address: **1100 30TH ST**

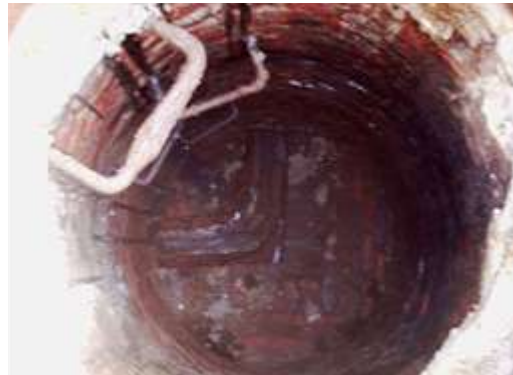
Top View

Corroded steps. Bench debris.

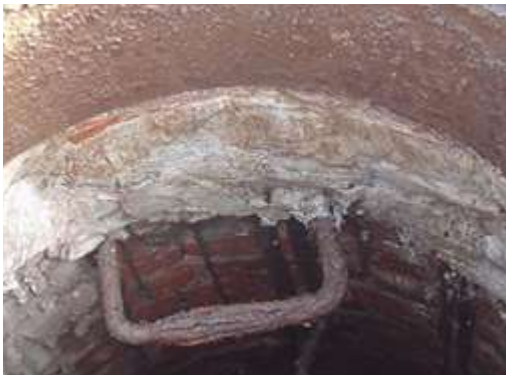
Defect

Frame Offset: **0** (in.) Condition: ☐ Sound ☐ Cracked ☒ **Leaks**

Infiltration: ☐ None ☒ **Joint** ☐ Cracks ☐ Mortar ☐ Roots ☒ **Wall**

Frame leaks. Corbel infiltration.

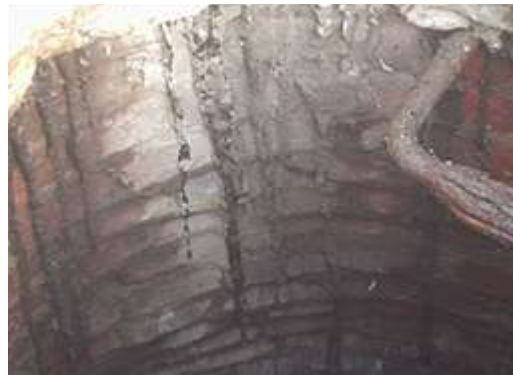
Defect

Corbel infiltration.

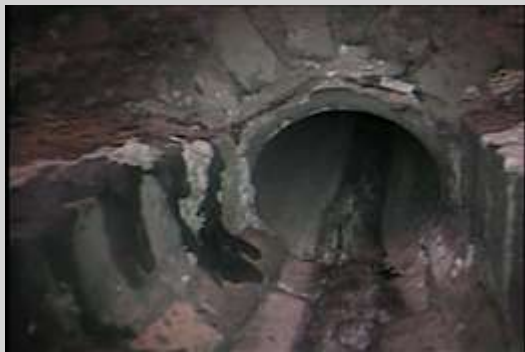
8 in. Circular Gravity Sewer Pipe Out @ 12 O'Clock

Infiltration: **Evidence** Pipe Seal Cond: **Cracked**

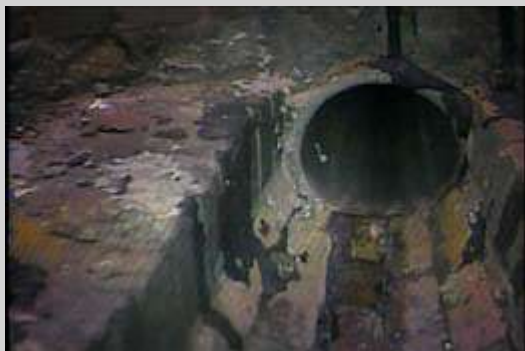
8 in. Circular Gravity Sewer Pipe In @ 9 O'Clock

Infiltration: **None** Pipe Seal Cond: **Unknown**
